**Flood Control Project Maintenance  
Levee Inspections**

**Fall 2018 Levee Maintenance Deficiency Summary Report**

**Reclamation District No. 2031 Elliot**

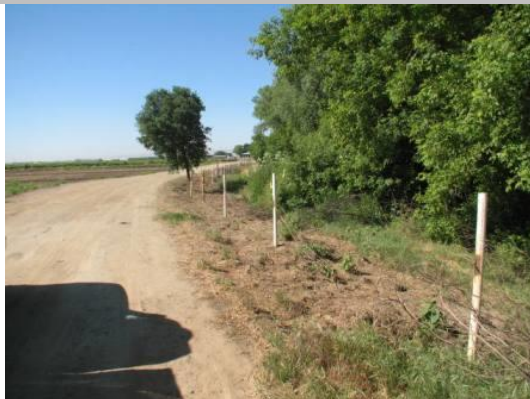
Photo 1 of 3 : FA\_2018\_RD2031\_307\_7\_20180918\_00004.jpg

LM Start	<b>0.34</b>	Rating **	M	Issue No.	<b>7 (cont)</b>
LM End	<b>0.52</b>	Issue Type +	En	Location *	WS

05/10/2011 Fence on waterside prevents access to waterside slope.

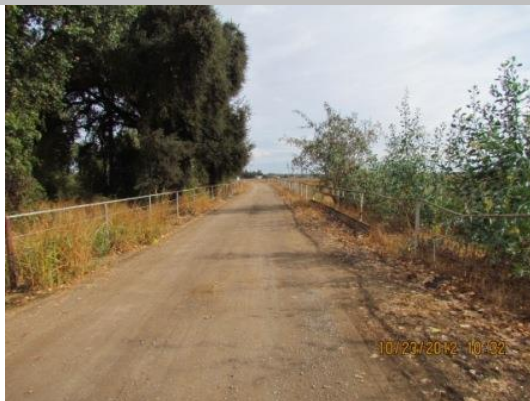
Photo 2 of 3 : FA\_2018\_RD2031\_307\_7\_20180918\_00005.jpg

View of fence obstructing access to waterside slope. Facing upstream.

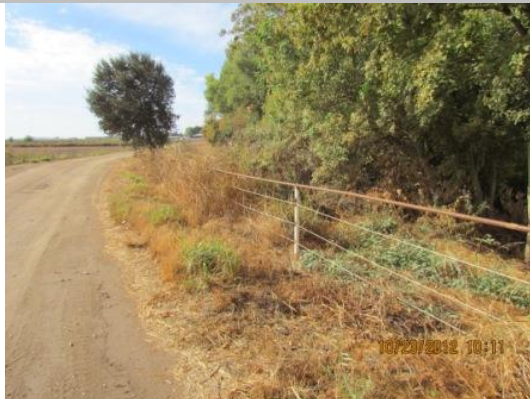
Photo 3 of 3 : FA\_2018\_RD2031\_307\_7\_20180918\_00006.jpg

View of fence on waterside slope facing downstream.

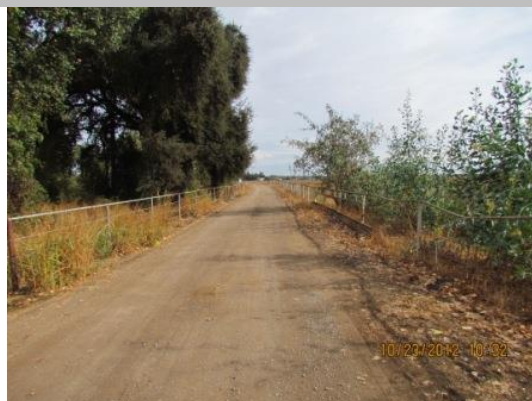
Photo 1 of 2 : FA\_2018\_RD2031\_307\_14\_20180918\_00009.jpg

LM Start	0.44	Rating **	M	Issue No.	14
LM End	0.53	Issue Type +	En	Location *	LS
Category	Earthen Levee			GPS Latitude/Longitude	
				Start	End
Item	Encroachments			37.704927 °	37.703788 °
				-121.158860 °	-121.159923 °
DWR ID	DWR_RD2031_01_f_2012_14				
Comment Code					
FE : Fence					
Inspector Comment					
It appears the fence was completed without CVFPB approval.

View of fence on landside levee shoulder obstructing access to landside slope. Facing upstream.

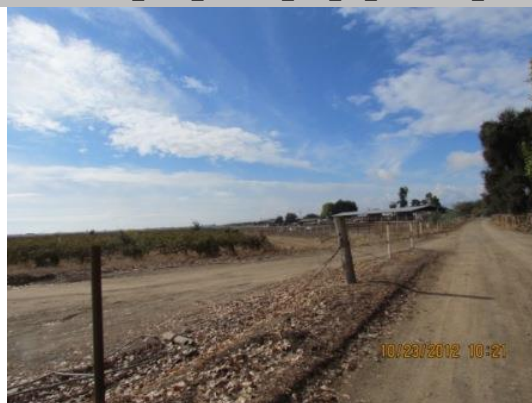
Photo 2 of 2 : FA\_2018\_RD2031\_307\_14\_20180918\_00010.jpg

LM Start	<b>0.44</b>	Rating **	M	Issue No.	<b>14 (cont)</b>
LM End	<b>0.53</b>	Issue Type +	En	Location *	LS

View of fence on landside levee shoulder facing downstream.

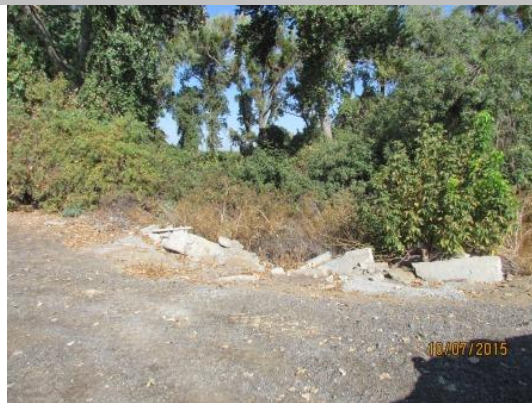
Photo 1 of 1 : FA\_2018\_RD2031\_307\_48\_20180918\_00026.jpg

LM Start	0.51	Rating **	M	Issue No.	48
LM End	0.51	Issue Type +	En	Location *	WS
Category	Earthen Levee			GPS Latitude/Longitude	
				Start	End
Item	Encroachments			37.704041°	37.704041°
				-121.159629°	-121.159629°
DWR ID	DWR_RD2031_01_f_2015_48				
Comment Code					
MA : Material					
Inspector Comment					
Concrete dumped on the waterside slope.

View of the concrete placed on the waterside levee slope.

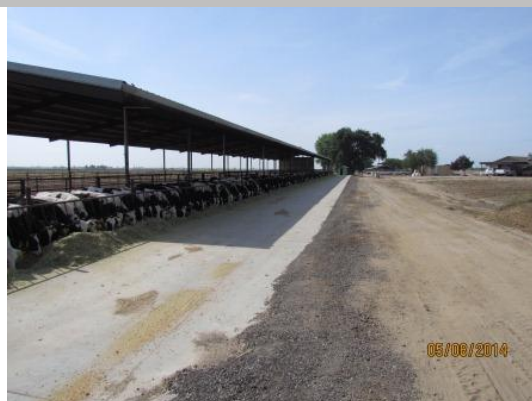
Photo 1 of 1 : FA\_2018\_RD2031\_307\_969\_20180918\_00044.jpg

LM Start	0.54	Rating **	U	Issue No.	969
LM End	0.57	Issue Type +	En	Location *	LS
Category	Earthen Levee			GPS Latitude/Longitude	
				Start	End
Item	Encroachments			37.703626 °	37.703300 °
				-121.159714 °	-121.159779 °
DWR ID	DWR_RD2031_01_s _ 2012_969				
Comment Code					
BU : Building					
Inspector Comment					
Corrals and house on levee slope and crown. The Corrals do not have CVFPB permit.

View of the new coral at the landside levee slope and toe.

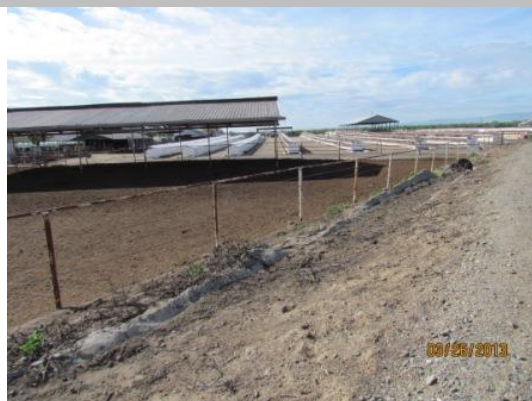
Photo 1 of 1 : FA\_2018\_RD2031\_307\_4\_20180918\_00003.jpg

LM Start	0.63	Rating **	M	Issue No.	4
LM End	0.72	Issue Type +	En	Location *	LS
Category	Earthen Levee			GPS Latitude/Longitude	
				Start	End
Item	Encroachments			37.702814 °	37.701875 °
				-121.160562 °	-121.161670 °
DWR ID	DWR_RD2031_01_s_2012_4				
Comment Code					
FE : Fence					
Inspector Comment

View of the fence at the landside levee toe.

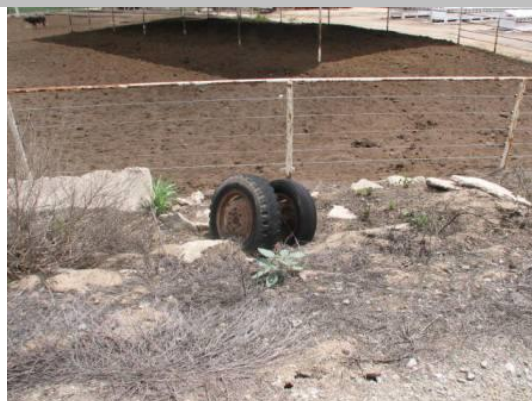
Photo 1 of 1 : FA\_2018\_RD2031\_307\_35\_20180918\_00015.jpg

LM Start	0.65	Rating **	M	Issue No.	35
LM End	0.65	Issue Type +	En	Location *	LS
Category	Earthen Levee			GPS Latitude/Longitude	
				Start	End
Item	Encroachments			37.702643 °	37.702643 °
				-121.160867 °	-121.160867 °
DWR ID	DWR_RD2031_01_s_2012_35				
Comment Code					
DE : Debris					
Inspector Comment					
Tractor wheels on slope of landside levee. It has been there since Spring 2012 inspection.

View of tractor wheels on landward slope. 05/02/2012

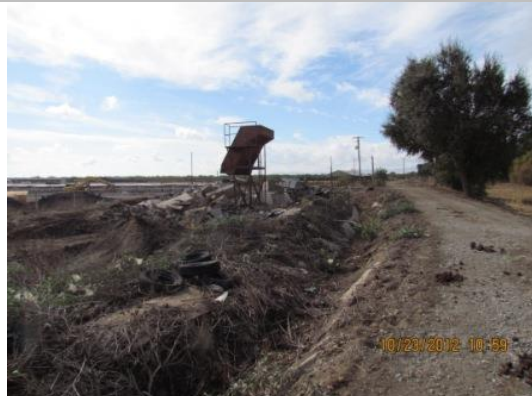
Photo 1 of 1 : FA\_2018\_RD2031\_307\_972\_20180918\_00045.jpg

LM Start	0.72	Rating **	M	Issue No.	972
LM End	0.76	Issue Type +	En	Location *	LS
Category	Earthen Levee			GPS Latitude/Longitude	
				Start	End
Item	Encroachments			37.701906°	37.701370°
				-121.161661°	-121.161986°
DWR ID	DWR_RD2031_01_s_2012_972				
Comment Code					
DT : Ditch					
Inspector Comment

View of the ditch on landside levee toe, facing downstream.

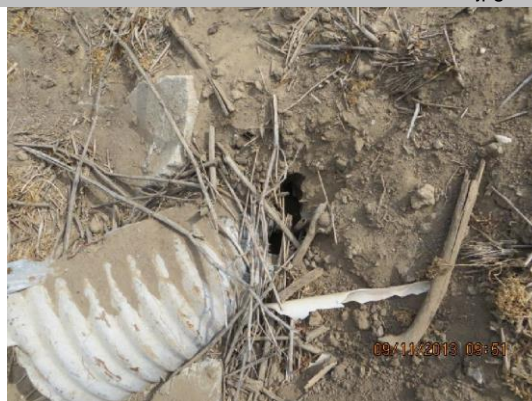
Photo 2 of 3 : UCIP\_FA\_2018\_20047\_33949.jpg

LM Start	0.75	Rating **	M	Issue No.	986 (cont)	
LM End	0.75	Issue Type +	En	Location *		
Category	Supplemental			GPS Latitude/Longitude		
				Start	End	
Item	DWR UCIP Field Study			37.701552 °	37.701552 °	
				-121.161883 °	-121.161883 °	
DWR ID	20441					
Comment Code						
Inspector Comment						
FS_ID:20047 DS_ID:20441 EP_NO: N/A Repair Type: Non-Urgent Crossing Status: Found UCIP Comments: This pipe appears abandoned and if so, should be done so appropriately. FIELD_STRUCT_DESC: 15-inch corrugated metal irrigation pipe through the levee, 4 feet below the crown. Flashboard slots on the landside (LS). Installed by USACE in 1966. [Additional Reference(s): DWR Levee Log, 2005. USACE San Joaquin O&M Manual 4, June 1968, (HLM 0.75)]. FS Date: 9/11/2013

Hole in pipe at WS slope.

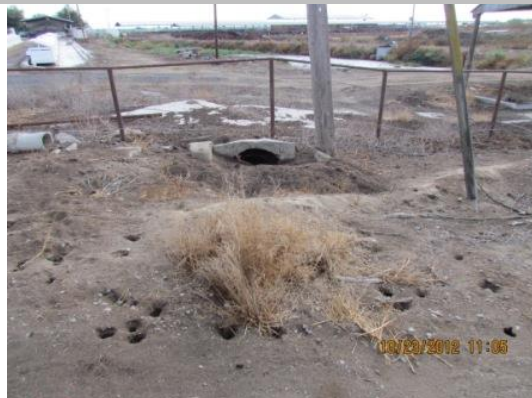
Photo 1 of 1 : FA\_2018\_RD2031\_307\_36\_20180918\_00016.jpg

LM Start	0.77	Rating **	M	Issue No.	36
LM End	0.77	Issue Type +	Ma	Location *	LS
Category	Earthen Levee			GPS Latitude/Longitude	
				Start	End
Item	Animal Control			37.701177°	37.701177°
				-121.162055°	-121.162055°
DWR ID	DWR_RD2031_01_f_2012_36				
Comment Code					
A3 : No rodents visible, but rodent burrows visible; need to backfill and compact or grout burrows.					
Inspector Comment

View of rodent burrows on landside slope.

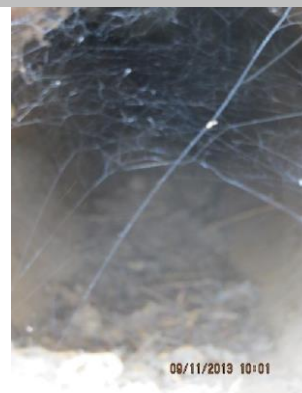
Photo 2 of 3 : UCIP\_FA\_2018\_20049\_33955.jpg

LM Start	0.80	Rating **	M	Issue No.	987 (cont)
LM End	0.80	Issue Type +	En	Location *	
Category	Supplemental			GPS Latitude/Longitude	
				Start	End
Item	DWR UCIP Field Study			37.700853 °	37.700853 °
				-121.162349 °	-121.162349 °
DWR ID	20443				
Comment Code					
Inspector Comment					
FS_ID:20049					
DS_ID:20443					
EP_NO: N/A					
Repair Type: Non-Urgent					
Crossing Status: Found					
UCIP Comments: Pipe appears abandoned as WS slope is covered with soil. If abandoned, it should be done so properly.					
FIELD_STRUCT_DESC: 24-inch steel irrigation pipe through the levee, 2 feet below the crown. Concrete headwalls on both sides of the levee crown. [Additional Reference(s): DWR Levee Log, 2005. USACE San Joaquin O&M Manual 4, June 1968, (HLM 0.81)].					
FS Date: 9/11/2013

Pipe not filled with concrete.

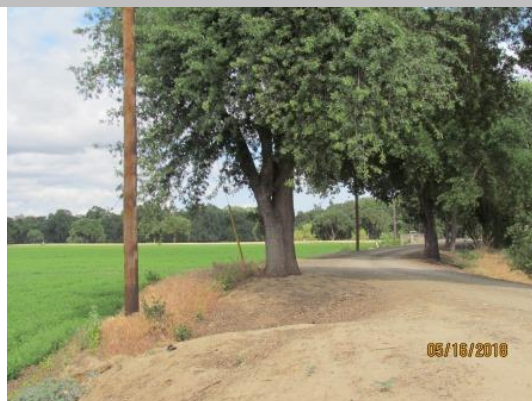
Photo 1 of 1 : FA\_2018\_RD2031\_307\_47\_20180918\_00025.jpg

LM Start	1.22	Rating **	M	Issue No.	47
LM End	1.27	Issue Type +	En	Location *	LS
Category	Earthen Levee			GPS Latitude/Longitude	
				Start	End
Item	Encroachments			37.699018 °	37.699507 °
				-121.169233 °	-121.169913 °
DWR ID	DWR_RD2031_01_s_2018_47				
Comment Code					
PO : Pole					
Inspector Comment					
Three power poles on levee and levee slope.

View looking downstream landside of three power poles on the levee and levee slope.

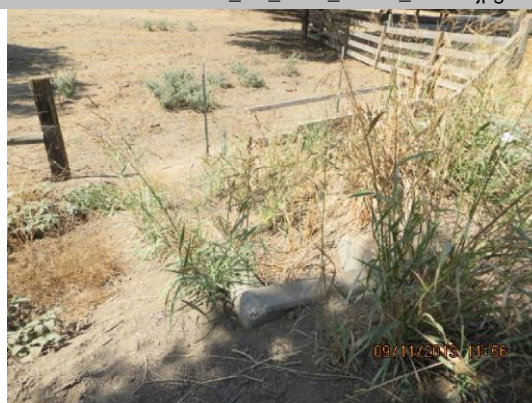
Photo 1 of 3 : UCIP\_FA\_2018\_20109\_34075.jpg

LM Start	1.86	Rating **	M	Issue No.	993
LM End	1.86	Issue Type +	En	Location *	
Category	Supplemental			GPS Latitude/Longitude	
				Start	End
Item	DWR UCIP Field Study			37.695737 °	37.695737 °
				-121.177533 °	-121.177533 °
DWR ID	20448				
Comment Code					
Inspector Comment					
FS_ID:20109					
DS_ID:20448					
EP_NO: N/A					
Repair Type: Non-Urgent					
Crossing Status: Found					
UCIP Comments: If abandoned it should be done so properly if not, the pipe should be cleared of soil blockage.					
FIELD_STRUCT_DESC: *ABANDONED* 24-inch drainage pipe of an unknown material through the levee, 6.8 feet below the crown. Concrete headwalls on both ends. Flap gate on the waterside (WS) end. Installed by USACE in 1966. [Additional Reference(s): DWR Levee Log, 2005. USACE San Joaquin O&M Manual 4, June 1968].					
FS Date: 9/11/2013

Concrete U-shaped headwall on WS toe.

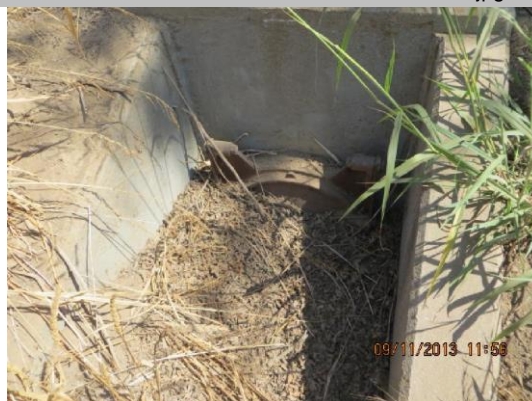
Photo 2 of 3 : UCIP\_FA\_2018\_20109\_34074.jpg

LM Start	1.86	Rating **	M	Issue No.	993 (cont)	
LM End	1.86	Issue Type +	En	Location *		
Category	Supplemental			GPS Latitude/Longitude		
				Start	End	
Item	DWR UCIP Field Study			37.695737 °	37.695737 °	
				-121.177533 °	-121.177533 °	
DWR ID	20448					
Comment Code						
Inspector Comment						
FS_ID:20109 DS_ID:20448 EP_NO: N/A Repair Type: Non-Urgent Crossing Status: Found UCIP Comments: If abandoned it should be done so properly if not, the pipe should be cleared of soil blockage. FIELD_STRUCT_DESC: *ABANDONED* 24-inch drainage pipe of an unknown material through the levee, 6.8 feet below the crown. Concrete headwalls on both ends. Flap gate on the waterside (WS) end. Installed by USACE in 1966. [Additional Reference(s): DWR Levee Log, 2005. USACE San Joaquin O&M Manual 4, June 1968]. FS Date: 9/11/2013

Flapgate on WS toe.

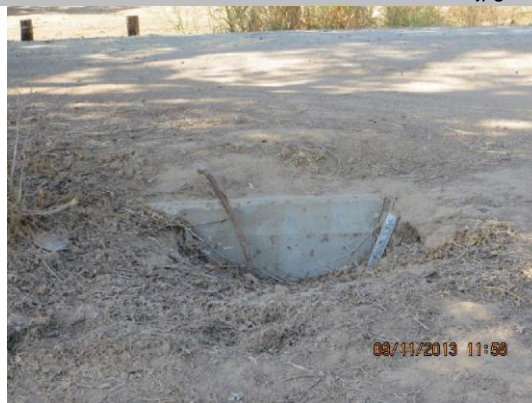
Photo 3 of 3 : UCIP\_FA\_2018\_20109\_34073.jpg

Concrete headwall on LS shoulder.

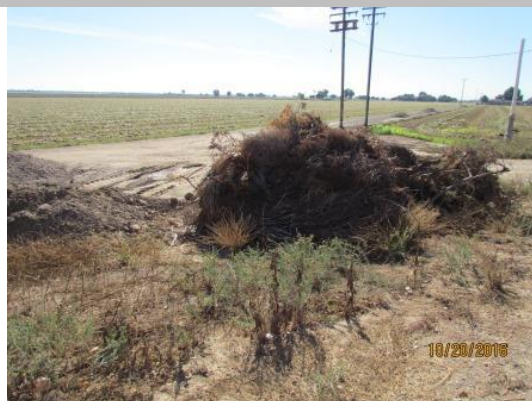
Photo 2 of 2 : FA\_2018\_RD2031\_307\_53\_20180918\_00031.jpg

LM Start	2.40	Rating **	M	Issue No.	53 (cont)	
LM End	2.44	Issue Type +	En	Location *	LS	
Category	Earthen Levee			GPS Latitude/Longitude		
				Start		End
Item	Encroachments			37.688465 °	37.688064 °	
				-121.179821 °	-121.180175 °	
DWR ID	DWR_RD2031_01_s_2015_53					
Comment Code						
DE : Debris						
Inspector Comment

View of another debris pile in close proximity of the previous photo.

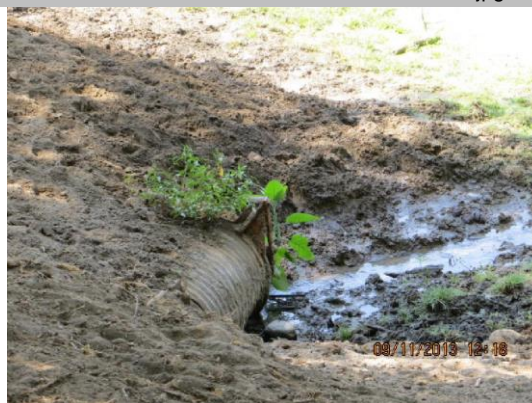
Photo 1 of 3 : UCIP\_FA\_2018\_51340\_39002.jpg

LM Start	2.45	Rating **	M	Issue No.	995	
LM End	2.45	Issue Type +	En	Location *		
Category	Supplemental			GPS Latitude/Longitude		
				Start	End	
Item	DWR UCIP Field Study			37.687949 °	37.687949 °	
				-121.180305 °	-121.180305 °	
DWR ID	24669

Comment Code						
Inspector Comment						
FS_ID:51340 DS_ID:24669 EP_NO: N/A Repair Type: Non-Urgent Crossing Status: Found UCIP Comments: 11/16/2016 No access to WS due to cattle fence in place. Need to coordinate with property owner to obtain access on WS. Unable to find inlet on LS. Reommand internal inspection of crossing. Crossing has been downgraded from Urgent to Non-Urgent no signs of leaks where present on crown or slopes where pipe should be. (O. Magana - DWR UCIP)09/11/2013 Flapgate partially blocked by soil on WS toe. Good candidate for video inspection. (W. Wylie - DWR UCIP) FIELD_STRUCT_DESC: 24-inch corrugated metal drainage pipe through the levee, at an unknown depth. Flap gate on the waterside (WS) toe. Pipe may originate at a concrete distribution box on the landside (LS) toe. FS Date: 11/16/2016

Flapgate and pipe visible on WS toe.

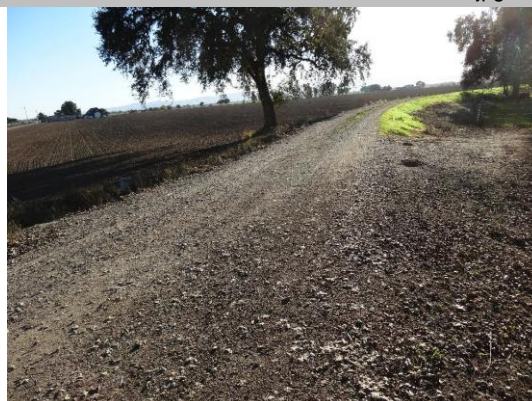
Photo 2 of 3 : UCIP\_FA\_2018\_51340\_76567.jpg

Overview of levee crown where pipe should cross levee. Limited access on WS due to fence.

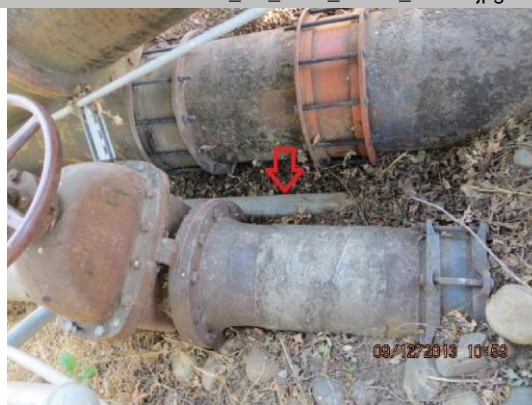
Photo 1 of 2 : UCIP\_FA\_2018\_22843\_39015.jpg

LM Start	3.69	Rating **	M	Issue No.	998
LM End	3.69	Issue Type +	En	Location *	
Category	Supplemental			GPS Latitude/Longitude	
				Start	End
Item	DWR UCIP Field Study			37.689742 °	37.689742 °
				-121.198778 °	-121.198778 °
DWR ID	24672				
Comment Code					
Inspector Comment					
FS_ID:22843 DS_ID:24672 EP_NO: N/A Repair Type: Non-Urgent Crossing Status: Found UCIP Comments: No permit identified for this possible crossing. FIELD_STRUCT_DESC: 4-inch steel irrigation pipe through the levee, at an unknown depth. Pipe visible between larger irrigation pipes below slant pump on the waterside (WS) slope. FS Date: 9/12/2013

Pipe visible between larger irrigation pipes below slant pump on WS slope.

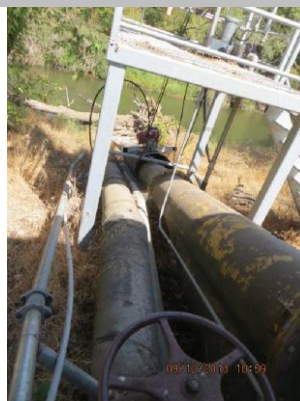
Photo 2 of 2 : UCIP\_FA\_2018\_22843\_39014.jpg

LM Start	3.69	Rating **	M	Issue No.	998 (cont)	
LM End	3.69	Issue Type +	En	Location *		
Category	Supplemental			GPS Latitude/Longitude		
				Start	End	
Item	DWR UCIP Field Study			37.689742 °	37.689742 °	
				-121.198778 °	-121.198778 °	
DWR ID	24672					
Comment Code						
Inspector Comment						
FS_ID:22843 DS_ID:24672 EP_NO: N/A Repair Type: Non-Urgent Crossing Status: Found UCIP Comments: No permit identified for this possible crossing. FIELD_STRUCT_DESC: 4-inch steel irrigation pipe through the levee, at an unknown depth. Pipe visible between larger irrigation pipes below slant pump on the waterside (WS) slope. FS Date: 9/12/2013

Pipe visible between larger irrigation pipes below slant pump on WS slope.

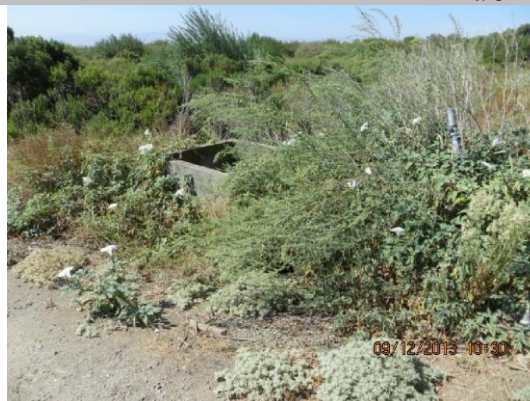
Photo 1 of 3 : UCIP\_FA\_2018\_20667\_34750.jpg

Comment Code						
Inspector Comment						
FS_ID:20667						
DS_ID:20456						
EP_NO: N/A						
Repair Type: Non-Urgent						
Crossing Status: Found						
UCIP Comments: Siphon breaker missing from LS shoulder. Fish screen and pipe end covered in debris that may cause damage to pipe.						
FIELD_STRUCT_DESC: 1 of 2: 20-inch steel irrigation pipe through the levee, 3.9 feet below the crown. Slant pump in pump house mounted on piles on the berm. Siphon breaker in a corrugated metal pipe (CMP) riser on the landside (LS) shoulder. Service pole on the LS slope. 5-foot by 5-foot concrete distribution box on the LS toe with flap gate.						
[Additional Reference(s): DWR Levee Log, 2005. USACE San Joaquin O&M Manual 4, June 1968, (HLM 3.70)].						
FS Date: 9/12/2013

Concrete distribution box on LS slope.

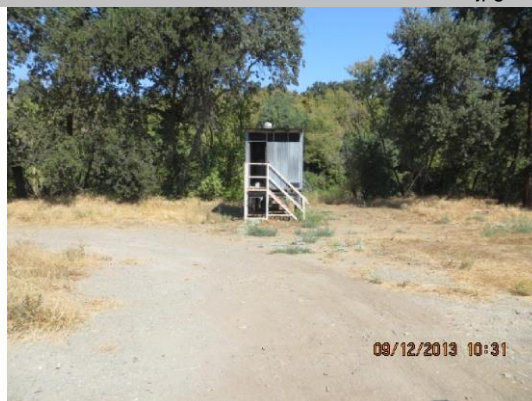
Photo 2 of 3 : UCIP\_FA\_2018\_20667\_34749.jpg

Slant pump in pump house on WS berm.

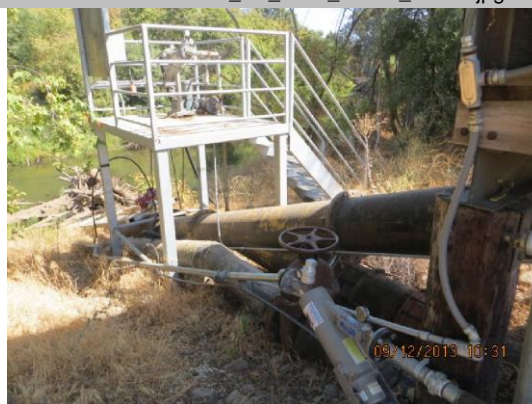
Photo 2 of 3 : UCIP\_FA\_2018\_22845\_39020.jpg

Pipe and appurtenances visible on downstream side of and next to larger irrigation pipe.

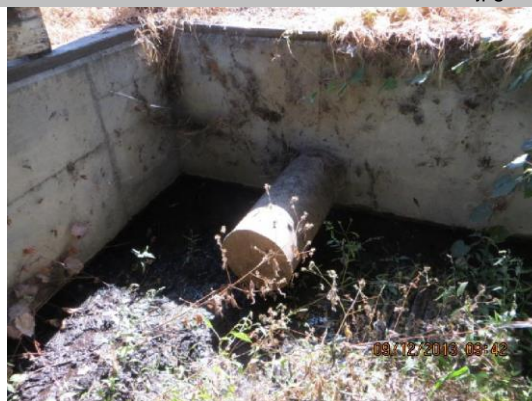
Photo 2 of 3 : UCIP\_FA\_2018\_20683\_34781.jpg

Welded steel plate over WS end of pipe.

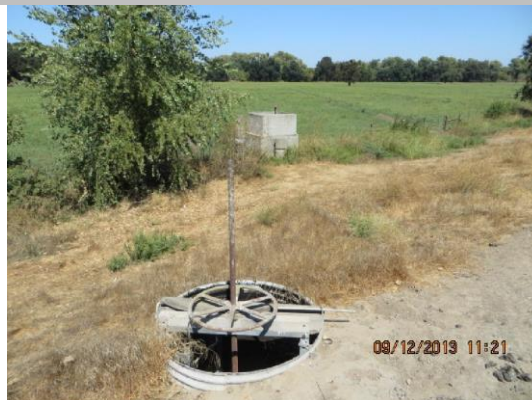
Photo 2 of 2 : UCIP\_FA\_2018\_20688\_34798.jpg

Slide gate in CMP riser on WS shoulder with concrete distribution box visible in background at WS toe.

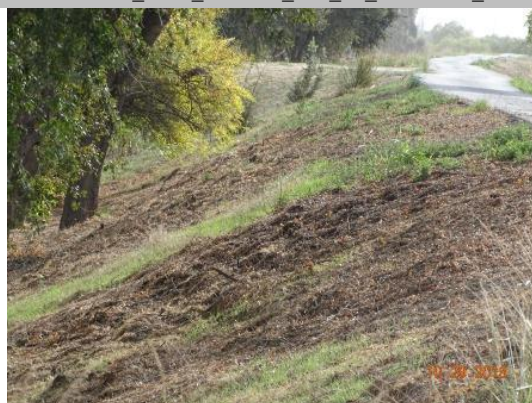
Photo 1 of 1 : FA\_2018\_RD2031\_308\_15\_20181108\_00050.jpg

LM Start	0.16	Rating **	A	Issue No.	15
LM End	5.96	Issue Type +	Ma	Location *	LS
Category	Earthen Levee			GPS Latitude/Longitude	
				Start	End
Item	Vegetation			37.659683 °	37.630752 °
				-121.233865 °	-121.159454 °
DWR ID	DWR_RD2031_02_f_2018_15				
Comment Code					
V1 : Control annual grass and weeds on the levee slopes and easements.					
Inspector Comment					
The annual vegetation is well maintained, Fall 2018.

View looking upstream landside of the well maintained annual vegetation, Fall 2018.

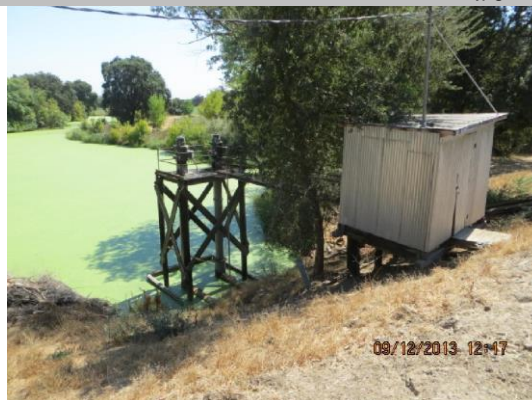
Photo 1 of 3 : UCIP\_FA\_2018\_20703\_34822.jpg

LM Start	0.22	Rating **	A/W	Issue No.	967
LM End	0.22	Issue Type +	Ma	Location *	
Category	Supplemental			GPS Latitude/Longitude	
				Start	End
Item	DWR UCIP LMA Responsibility			37.658888 °	37.658888 °
				-121.234274 °	-121.234274 °
DWR ID	20482				
Comment Code					
Inspector Comment					
FS_ID:20703					
DS_ID:20482					
EP_NO: N/A					
Repair Type: No Action Needed					
Crossing Status: Found					
UCIP Comments:					
FIELD_STRUCT_DESC: 1 of 2: 24-inch steel drainage pipe through the levee, 3.6 feet below the crown. Concrete U-shaped headwall on the waterside (WS) end. Flap gate on the WS end. Pump on pile structure on the landside (LS). [Additional Reference(s): DWR Levee Log, 2005. USACE San Joaquin O&M Manual 4, June 1968, (HLM 0.24)].					
FS Date: 9/12/2013

Pump on platform at LS toe.

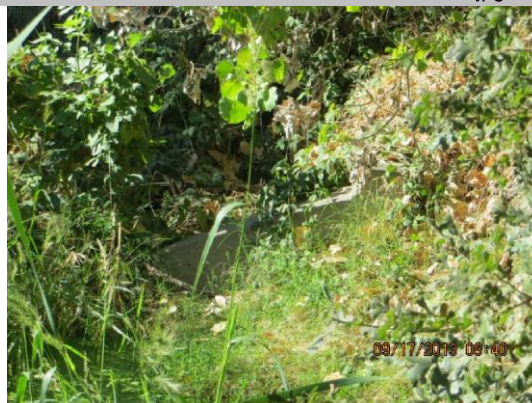
Photo 3 of 3 : UCIP\_FA\_2018\_52629\_34833.jpg

Concrete headwall on LS toe at edge of pond.

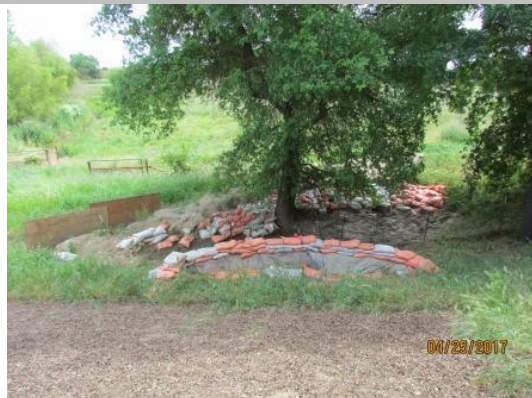
Photo 1 of 1 : FA\_2018\_RD2031\_308\_22\_20180918\_00009.jpg

LM Start	0.33	Rating **	U	Issue No.	22
LM End	0.33	Issue Type +	Ob	Location *	LS
Category	Earthen Levee			GPS Latitude/Longitude	
				Start	End
Item	Seepage / Sandboils			37.657380 °	37.657380 °
				-121.235006 °	-121.235006 °
DWR ID	DWR_RD2031_02_s_2017_22				
Comment Code					
Inspector Comment

View of the sack rings at the levee toe.

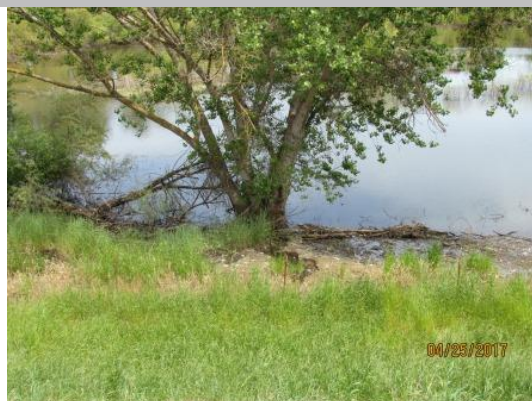
Photo 1 of 1 : FA\_2018\_RD2031\_308\_24\_20180918\_00010.jpg

LM Start	0.75	Rating **	U	Issue No.	24
LM End	1.11	Issue Type +	Ob	Location *	LS
Category	Earthen Levee			GPS Latitude/Longitude	
				Start	End
Item	Seepage / Sandboils			37.653954°	37.651915°
				-121.229623°	-121.223617°
DWR ID	DWR_RD2031_02_s_2017_24				
Comment Code					
Inspector Comment

View of the seepage at the levee toe.

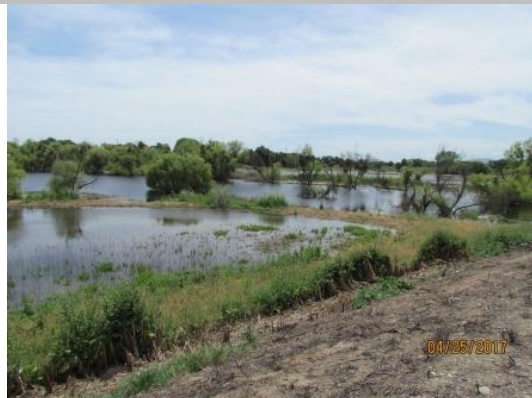
Photo 1 of 2 : FA\_2018\_RD2031\_308\_27\_20180918\_00012.jpg

LM Start	1.58	Rating **	U	Issue No.	27
LM End	2.33	Issue Type +	Ob	Location *	LS
Category	Earthen Levee			GPS Latitude/Longitude	
				Start	End
Item	Seepage / Sandboils			37.645656 °	37.640520 °
				-121.220463 °	-121.218078 °
DWR ID	DWR_RD2031_02_s_2017_27				
Comment Code					
Inspector Comment

Another view of the seepage at the levee toe.

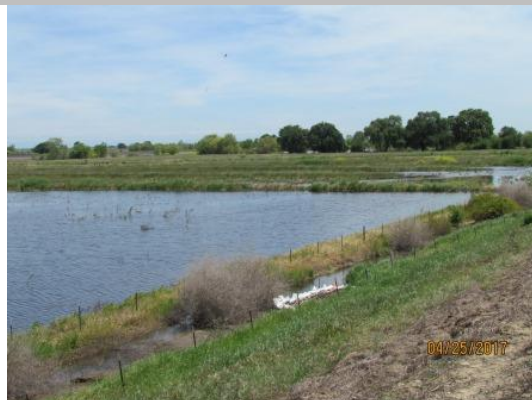
Photo 2 of 2 : FA\_2018\_RD2031\_308\_27\_20180918\_00013.jpg

View of the seepage and boils at the levee toe.

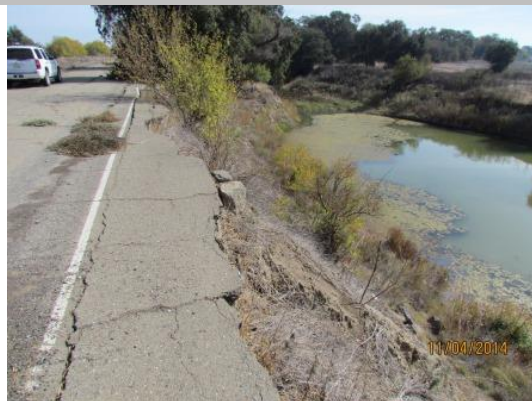
Photo 1 of 1 : FA\_2018\_RD2031\_308\_26\_20180918\_00011.jpg

LM Start	2.27	Rating **	U	Issue No.	26
LM End	2.28	Issue Type +	Ob	Location *	WS
Category	Earthen Levee			GPS Latitude/Longitude	
				Start	End
Item	Erosion / Bank Caving			37.640371 °	37.640340 °
				-121.219254 °	-121.218974 °
DWR ID	DWR_RD2031_02_f_2014_26				
Comment Code					
E1 : Note and monitor erosion site.					
Inspector Comment

View of the caving bank on the waterside facing upstream.

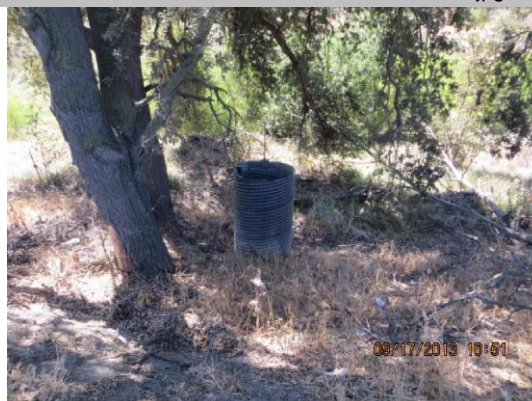
Photo 3 of 3 : UCIP\_FA\_2018\_20713\_34836.jpg

Comment Code						
Inspector Comment						
FS_ID:20713 DS_ID:20490 EP_NO: 11758 Repair Type: Non-Urgent Crossing Status: Found UCIP Comments: Pipe rusted through and failing at WS toe. Good indicator of internal condition of pipe. Good candidate for video inspection. FIELD_STRUCT_DESC: 24-inch corrugated metal gravity drainage pipe through the levee, 17 feet below the crown. 20-inch steel pipe and 1.25-inch galvanized conduit sleeved through the 24-inch pipe. Annular space pressure grouted. Slide gate in a 48-inch corrugated metal pipe (CMP) riser on the landside (LS) slope. 36-inch concrete standpipe at the LS toe with pump on a 48-inch steel standpipe. (20-inch and 1.5-inch pipes installed under Permit No. 11758, 1976 - Faith Ranch). [Additional Reference(s): DWR Levee Log, 2005. USACE San Joaquin O&M Manual 4, June 1968, (HLM 2.75)]. FS Date: 9/17/2013

Slide gate in 48-inch CMP riser on WS slope.

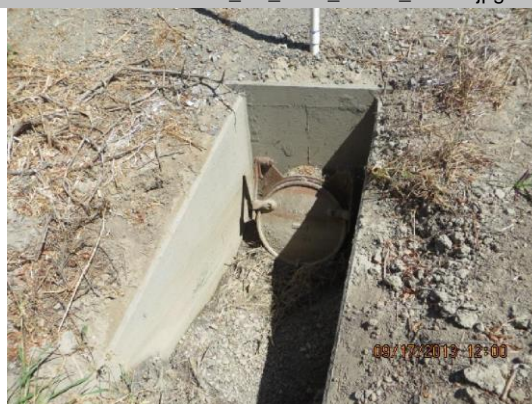
Photo 3 of 3 : UCIP\_FA\_2018\_51374\_34884.jpg

Flapgate on WS toe.

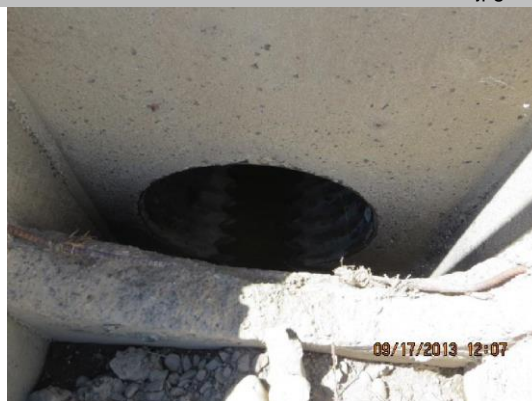
Photo 2 of 3 : UCIP\_FA\_2018\_20728\_34894.jpg

Concrete headwall on LS toe.

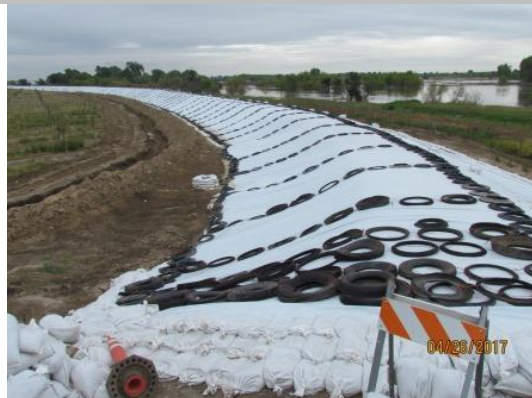
Photo 1 of 1 : FA\_2018\_RD2031\_308\_28\_20180918\_00014.jpg

LM Start	4.22	Rating **	U	Issue No.	28
LM End	4.51	Issue Type +	Ob	Location *	LS
Category	Earthen Levee			GPS Latitude/Longitude	
				Start	End
Item	Seepage / Sandboils			37.632448 °	37.630914 °
				-121.190601 °	-121.185914 °
DWR ID	DWR_RD2031_02_s_2017_28				
Comment Code					
Inspector Comment					
Raincoat applied to levee section and ditch cut about 12 feet from levee toe to intercept seepage.

View of the raincoat and seepage catch ditch near the levee.

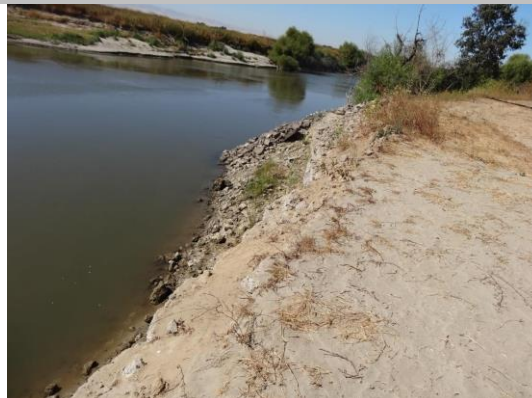
Photo 2 of 4 : FA\_2018\_RD2031\_308\_1\_20180918\_00002.jpg

10/04/2017: The erosion in the berm again was found further progressed toward levee toe.  
 07/08/2016: The erosion in the berm was found further progressed toward levee toe.  
 08/19/2015: No significant change observed.  
 07/17/2014: The erosion has slightly expanded toward levee toe at two pocket locations.  
 09/10/2013: The site has been visited. The erosion has expanded toward levee crest at two pocket locations.  
 07/18/2012: No significant change observed on the site.  
 08/18/2011: No significant change observed on the site. Dead trees and animal activities are visible. The closest point of the erosion site to the levee toe is about 100 ft.  
 10/19/2010: There is active scouring occurring on the bank due to the nature of the flow and the lack of armor protection. There is also a fallen log immediately downstream of where the erosion has occurred and is protruding outward, possibly creating an eddy and scouring the bank. With the remaining 100-foot wide berm, the levee prism is not yet affected. However, the bank will continue to degrade, and eventually intrude into the levee prism if no protection is put in place. Erosion site is recommended for annual assessment and monitoring during flood events. [2017 Site ID:RD2031U02RM78.7]

Looking downstream of the erosion site.

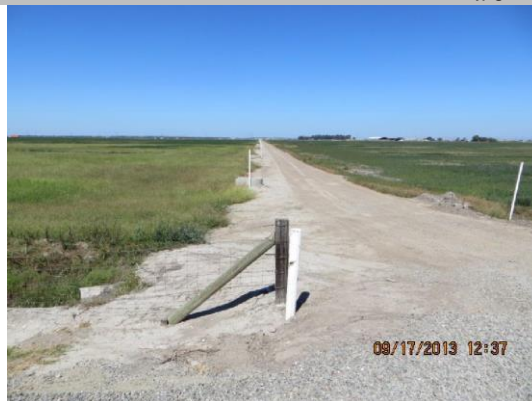
Photo 1 of 2 : UCIP\_FA\_2018\_22873\_39038.jpg

LM Start	5.63	Rating **	M	Issue No.	977
LM End	5.63	Issue Type +	En	Location *	
Category	Supplemental			GPS Latitude/Longitude	
				Start	End
Item	DWR UCIP Field Study			37.630779 °	37.630779 °
				-121.165402 °	-121.165402 °
DWR ID	24677				
Comment Code					
Inspector Comment					
FS_ID:22873 DS_ID:24677 EP_NO: N/A Repair Type: Non-Urgent Crossing Status: Found UCIP Comments: No permit identified for this crossing. FIELD_STRUCT_DESC: 24-inch polyvinyl chloride (PVC) irrigation pipe through the levee, 5 feet below the crown. Slide gate at the waterside (WS) shoulder. 6-inch steel riser on the WS shoulder. FS Date: 9/17/2013

Concrete turnouts visible off LS toe along road.

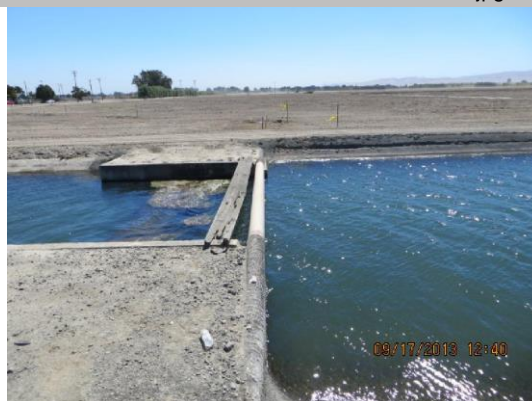
Photo 2 of 2 : UCIP\_FA\_2018\_20745\_34960.jpg

Gasline visible at crossing.
